CRITERIA OF REPLACEMENT STATE OF THE WIRBELSTAR KH

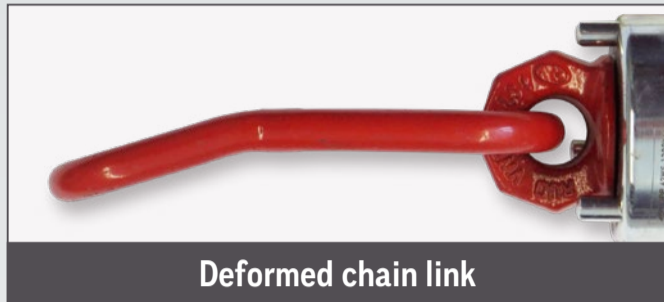
Deformed chain link

If one of the above-mentioned points is fulfilled the Wirbelstar KH has reached its replacement state and must not be used anymore.

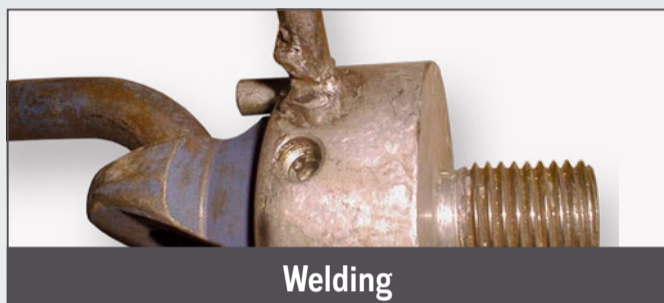
Welding

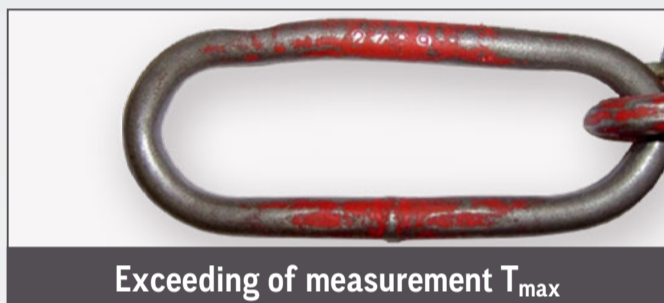
Exceeding of measurement T_{max}

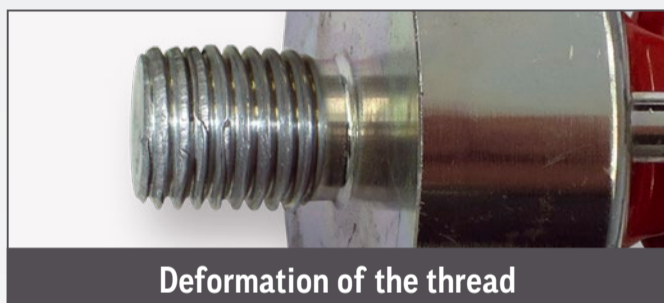
Deformation of the thread

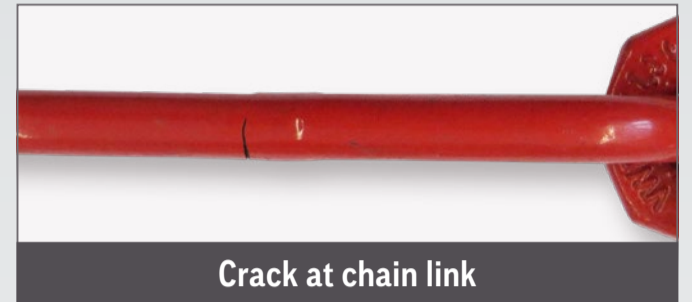
Crack at chain link

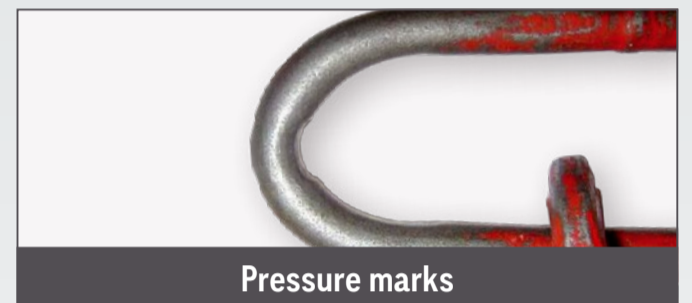
Pressure marks

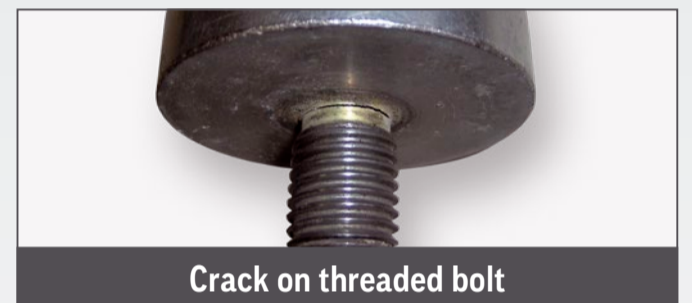
Crack on threaded bolt

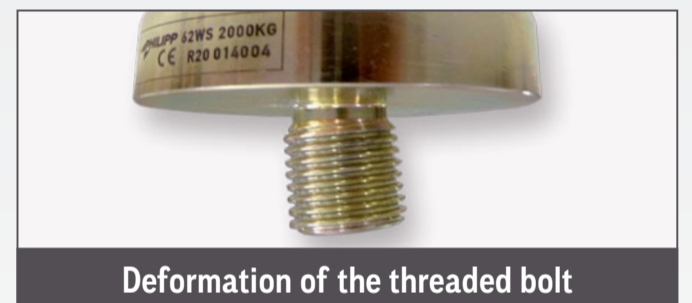
Deformation of the threaded bolt
